**CITY OF CARPINTERIA  
TREE ADVISORY BOARD**

#### Heath Ranch Park Tree Matters

**Kenneth A. Knight Consulting LLC**

Conduct a Level 2 risk assessment of five heritage Blue Gum Eucalyptus (*Eucalyptus globulus*) trees in Heath Ranch Park. A Level 2 assessment as defined by the American National Standard Institute (ANSI) A300 (part 9) Tree Risk Assessment standard is a detailed ground based 360 degree walk by each tree and visual inspection of a tree and its surrounding site using binoculars, mallet, probe, magnifying glass, diameter tape and trowel. A Level 2 assessment provides analysis of data, evaluation of risk and mitigation options.

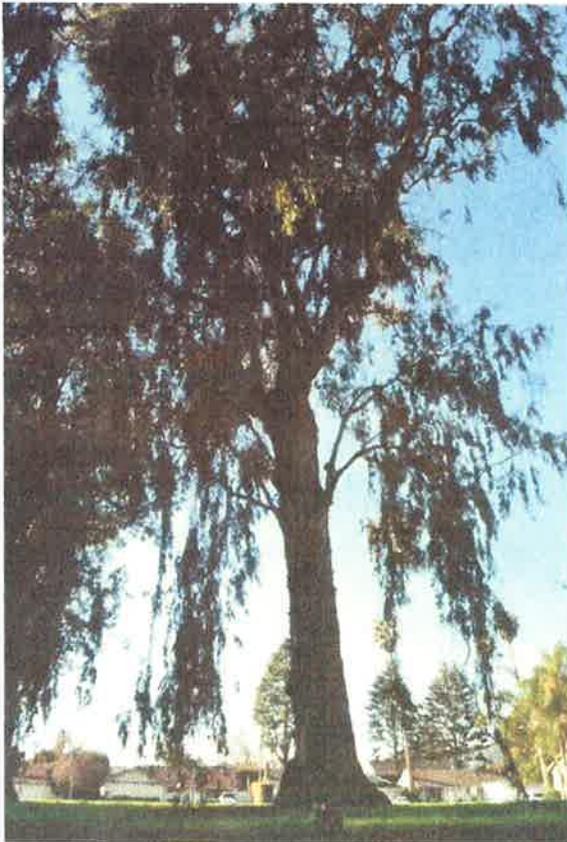
**Observations:** Tree 2 appears to be in good condition. The burl on the bottom of the tree is primarily hollow and does exhibit evidence of sap ooze. This appears to be slime ooze, a harmless bacteria infection and not symptoms of damage from eucalyptus long horned beetle insect activity.

**Tree Defects:** The parts of the tree most at risk of failure is weak scaffold branch approximately 2/3 of the way up the tree, and two overextended branches with weak attachments. Also possible root issues with sap oozing from burl.

**Tree 2 Risk Rating:** Moderate  
**Mitigation Options:** Reduce two overextended branches in the upper canopy, no parking on west side of Eucalyptus St. within target area, warning signage

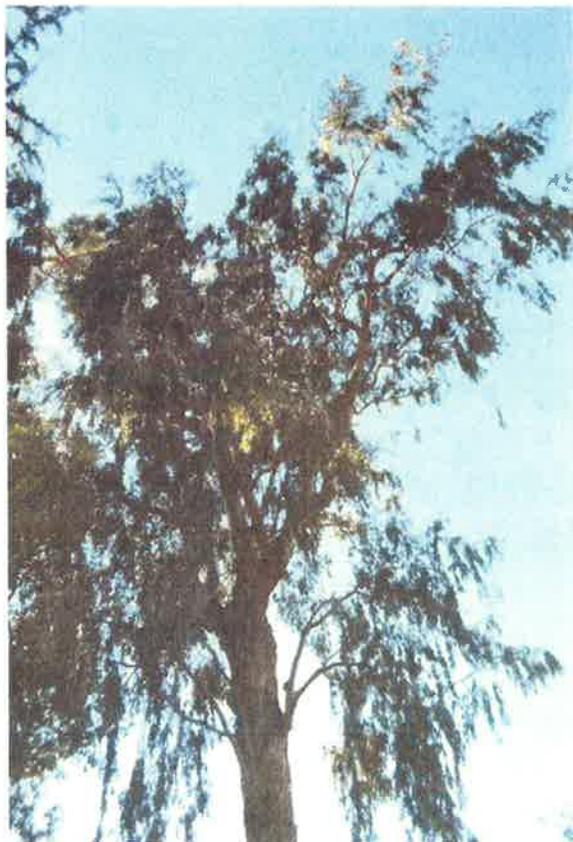
Potential scaffold reductions on north east side

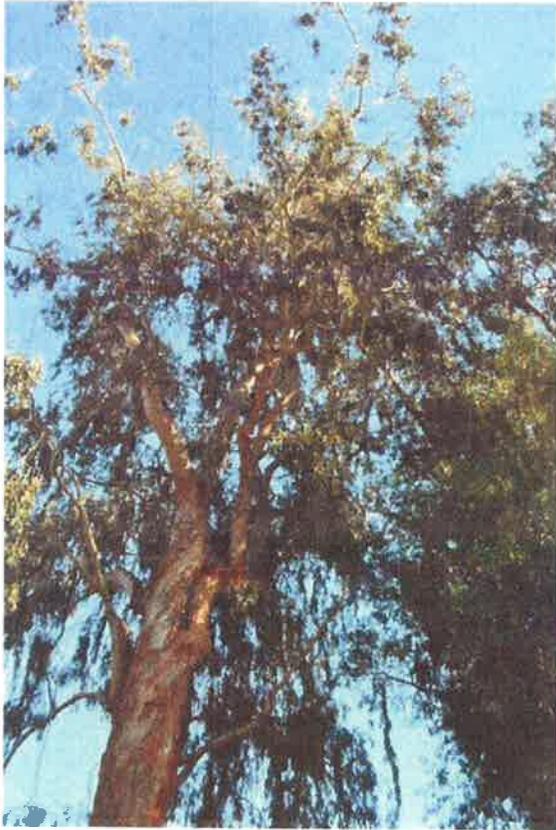
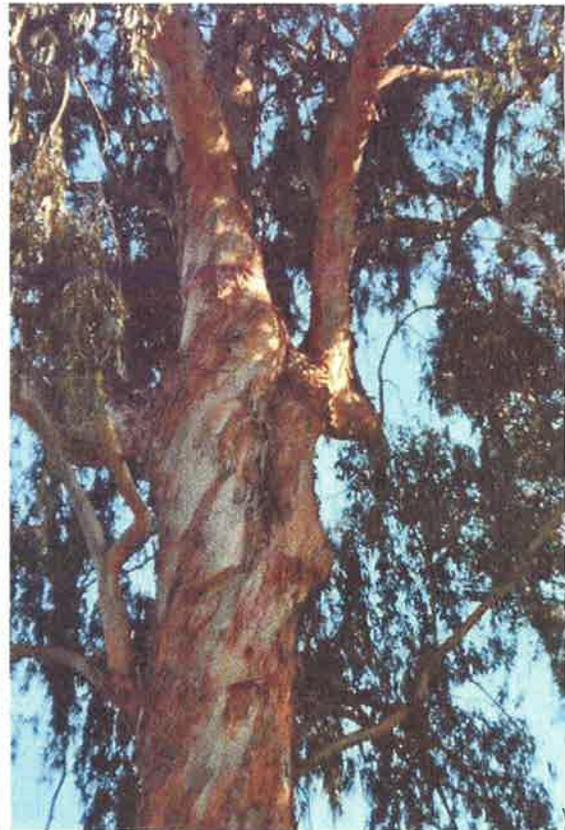
Weak attachment

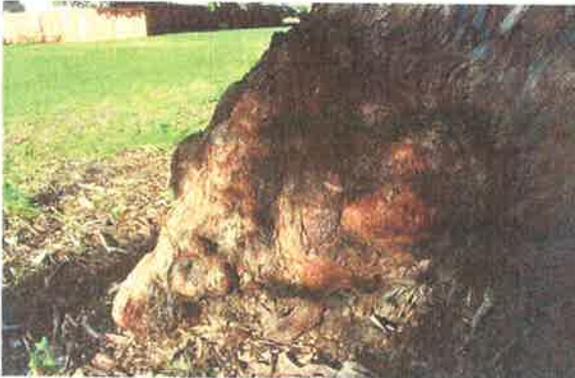
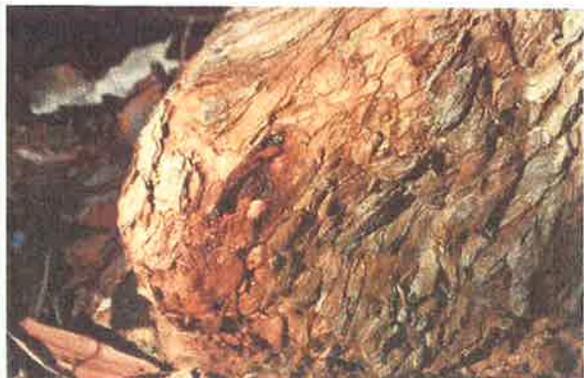
Sap oozing from burl

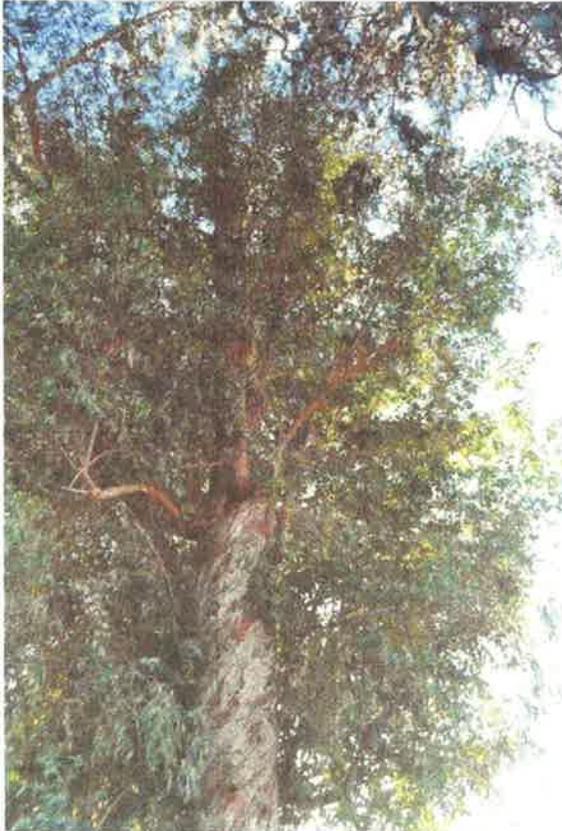
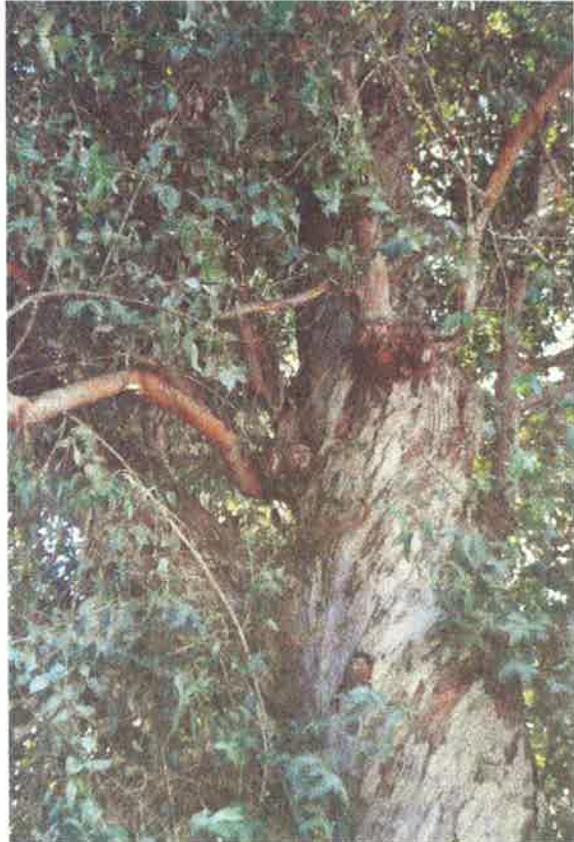
**Tree 3**  
**Species:** Tasmanian Blue Gum (*Eucalyptus globulus*)  
**DSH:** 36" Diameter at Standard Height  
**Height:** 70'  
**Canopy:** 49' (54' x 43')  
**Observations:** Tree 3 appears to be in good condition. Tree 3 is protected on three sides by trees 2, 4 and 5.  
**Tree Defects:** The parts of the tree most at risk of failure are the three, codominant scaffold branches approximately 15-20 feet up the tree.  
**Targets:** People walking in the Park under tree 2 and within 105' of the tree.  
**Likelihood of failure:** Unlikely  
**Likelihood of Impact:** High  
**Likelihood of impacting target matrix:** Unlikely  
**Consequences of failure:** Severe  
**Tree 2 Risk Rating:** Low  
**Mitigation Options:** None recommended  
**Residual risk:** Low

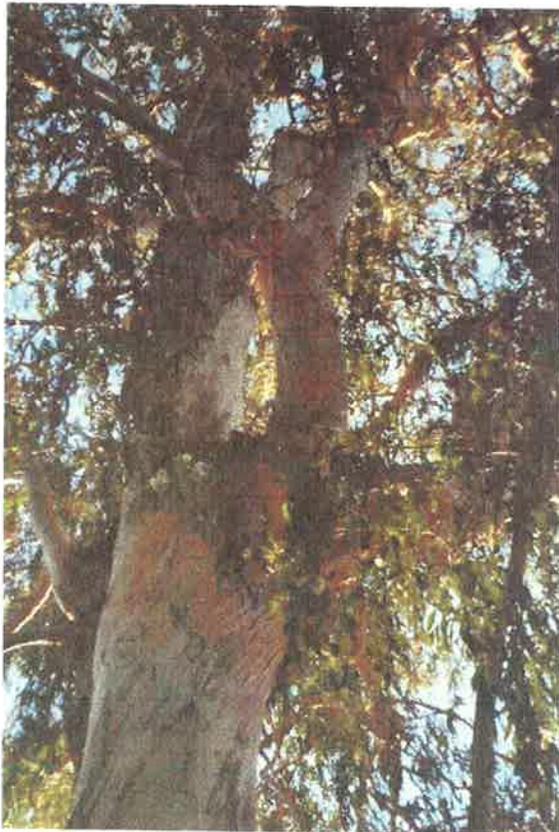
**Observations:** Tree 4 appears to be in good condition.  
**Tree Defects:** There are two parts of the tree most at risk of failure. The first is a approximately  $\frac{3}{4}$  up the trunk where three 25"+ scaffolds have V-joints extending from the main trunk. Although the scaffolds are large in relation to the main trunk, the joints do not have included bark.  
The second risk area is approximately half way up the trunk with three 25-30" scaffolds are within one foot of each other. The scaffold joints do not exhibit included bark, and the scaffolds are tapered, but overextended.

**Tree 4 Risk Rating:** Moderate  
**Mitigation Options:** Reduce length of overextended branches in middle and upper canopy  
**Residual risk:** Moderate

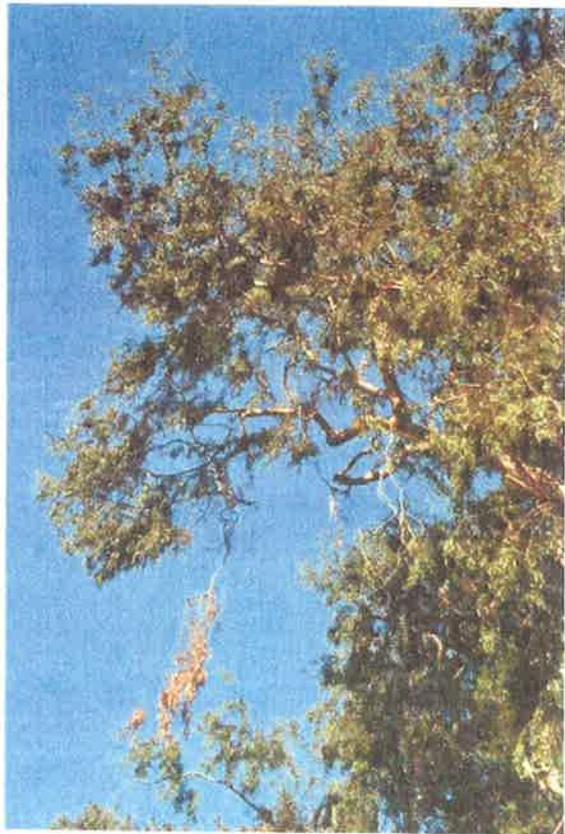
Potential scaffold reduction

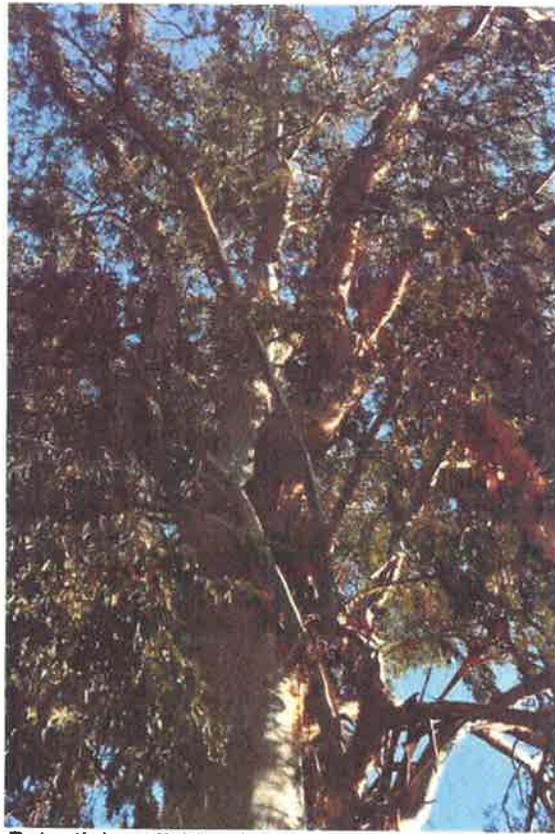
Potential scaffold reductions

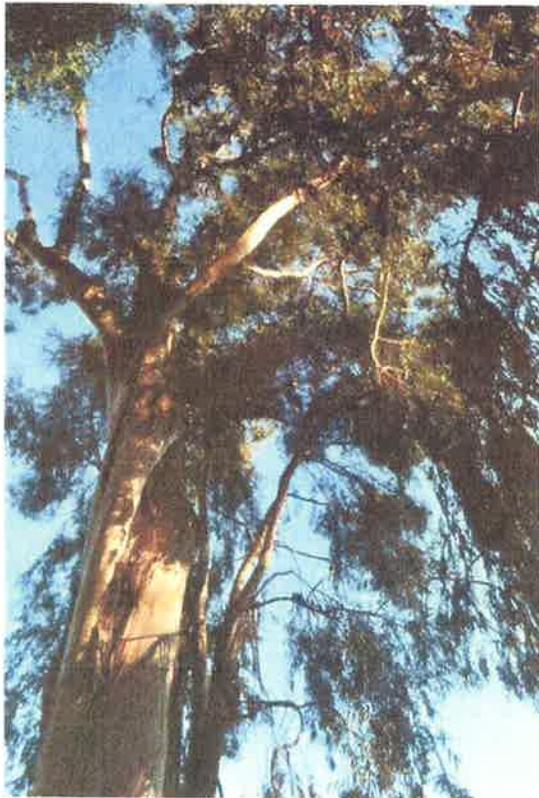
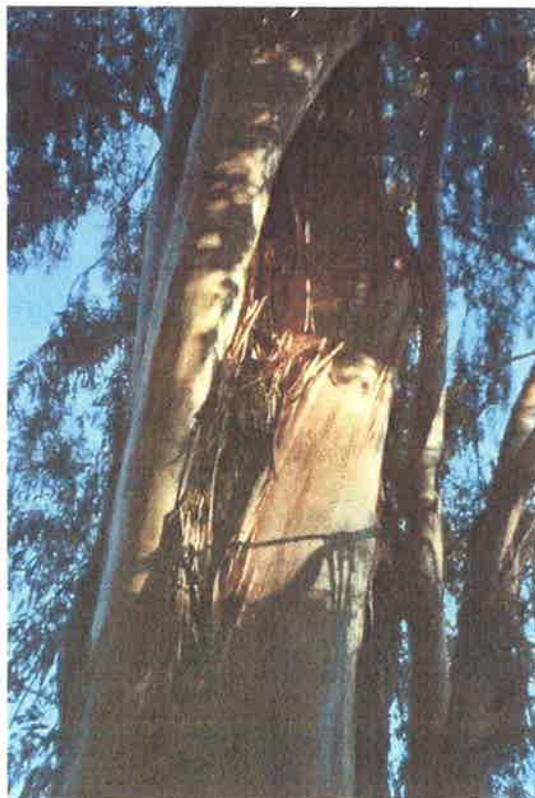
**Tree Defects:** The parts of the tree most at risk of failure are 1) the 30"+ scaffold branch half way up the tree on the northwest side that is overextended and lion-tailed. 2) The scaffold one quarter of the way up on the west side with a poor junction with the trunk. 3) The two over-extended branches three-quarter of the way up the tree on the east side

Tree 5 potential scaffold reduction

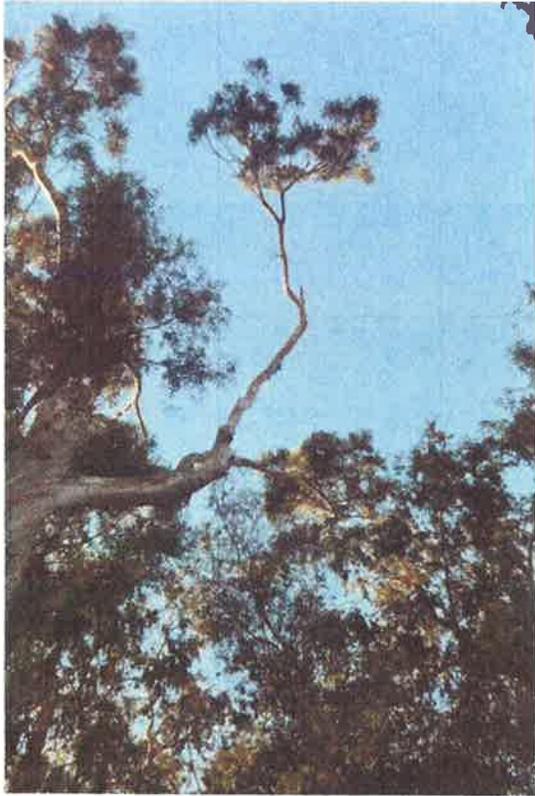
Tree 5 potential scaffold reduction

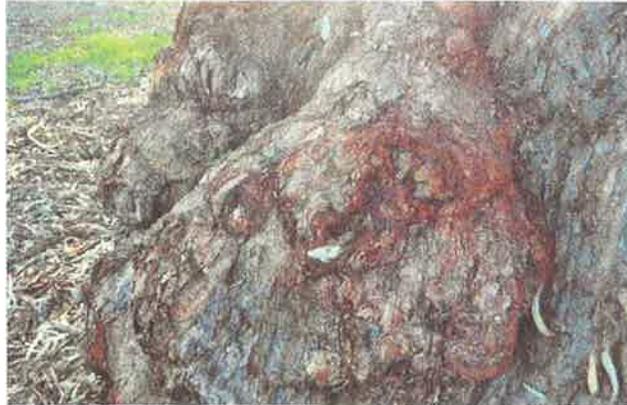
**Observations:** Tree 5 appears to be in good condition. Areas of white fungus are located on the north east side of the burl, which sounds mostly hollow

Fungus on burl

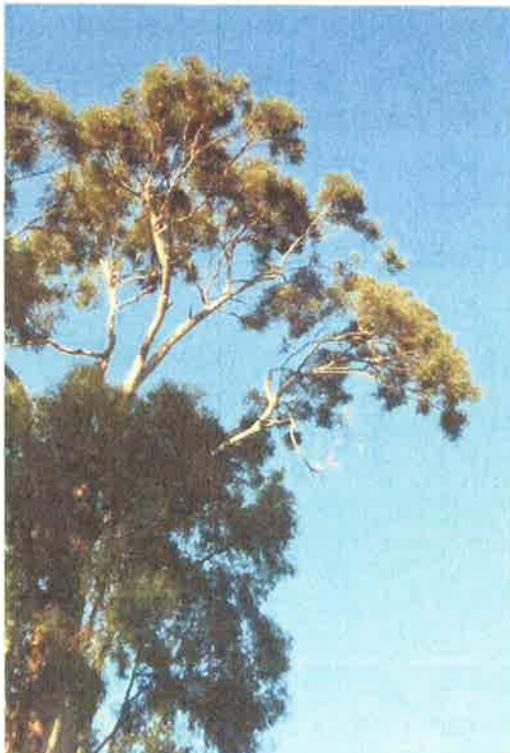
Potential scaffold reduction

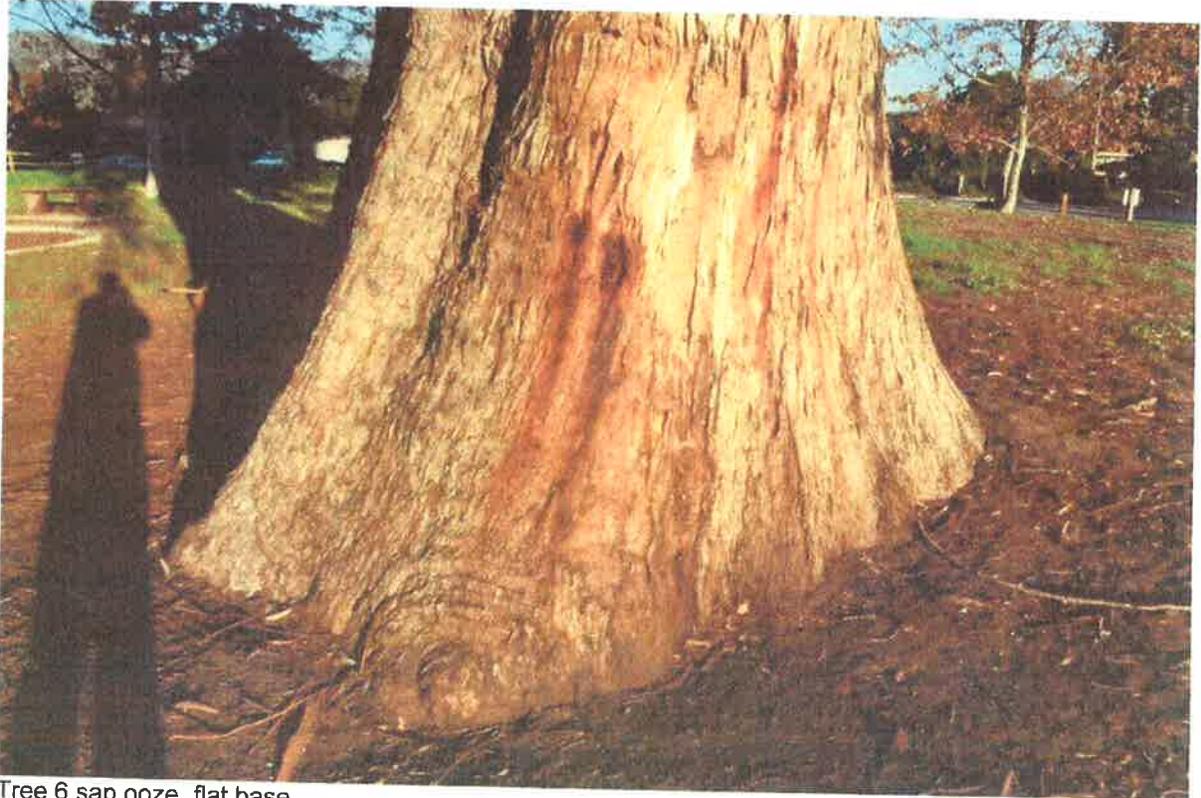
Tree 6 sap ooze, flat base

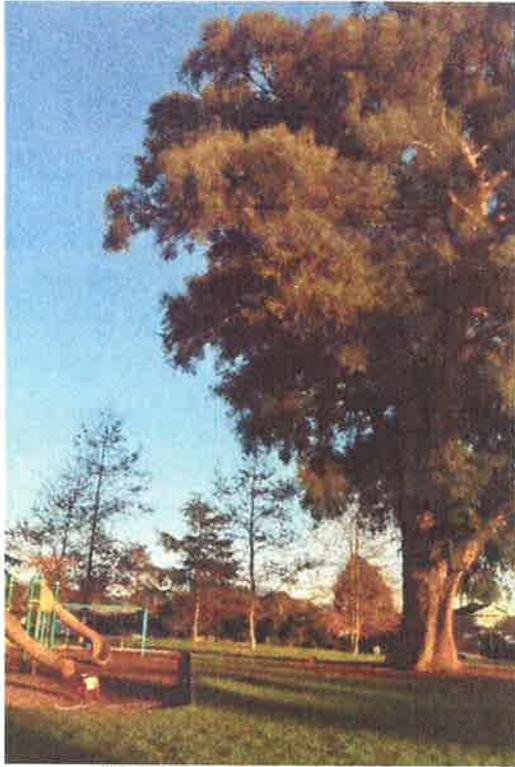
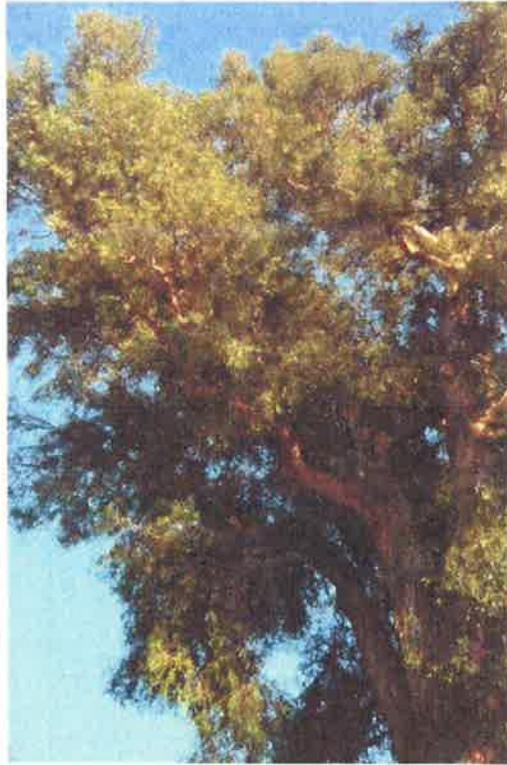
Tree 6 – Scaffold reduction on playground side

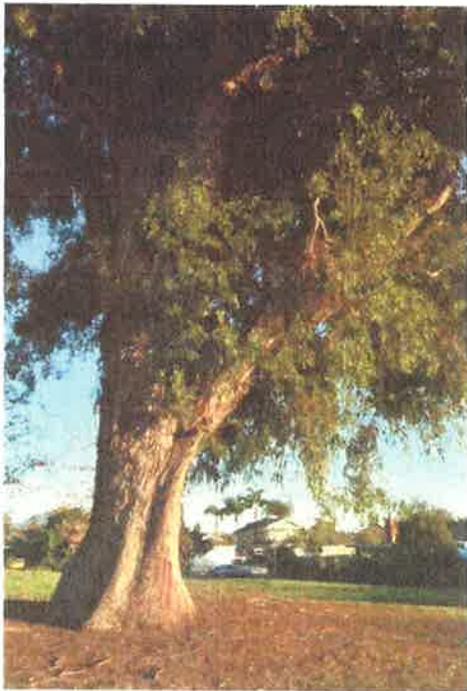
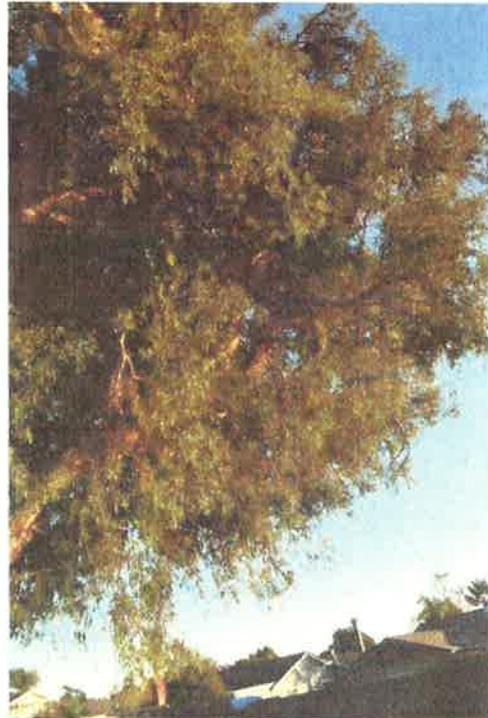
Tree 6 scaffold reduction

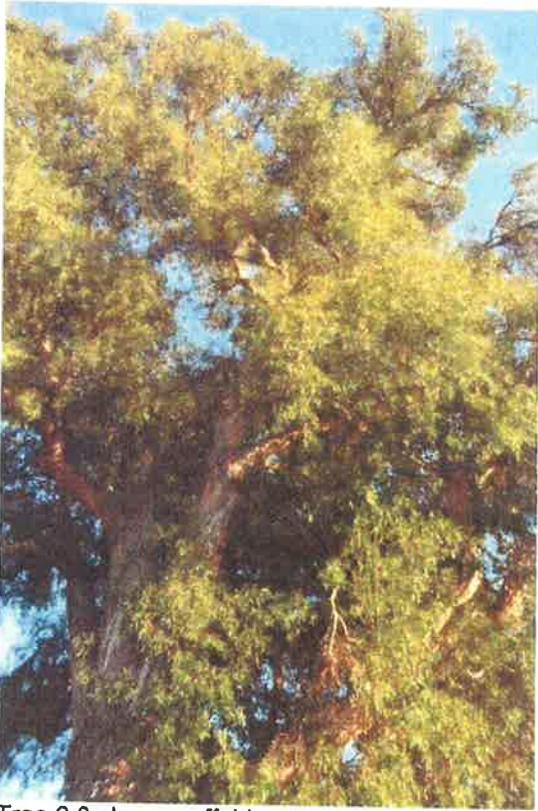
Tree 6 3 close scaffolds
