**CITY OF CARPINTERIA
TREE ADVISORY BOARD
Thursday, May 21, 2015**

Sanctuary Beach Condominiums – Discuss and give direction on proposed removal of a tree in the City right-of-way at 4295 Carpinteria Avenue

RE: Arborist Report for 4295 Carpinteria Avenue

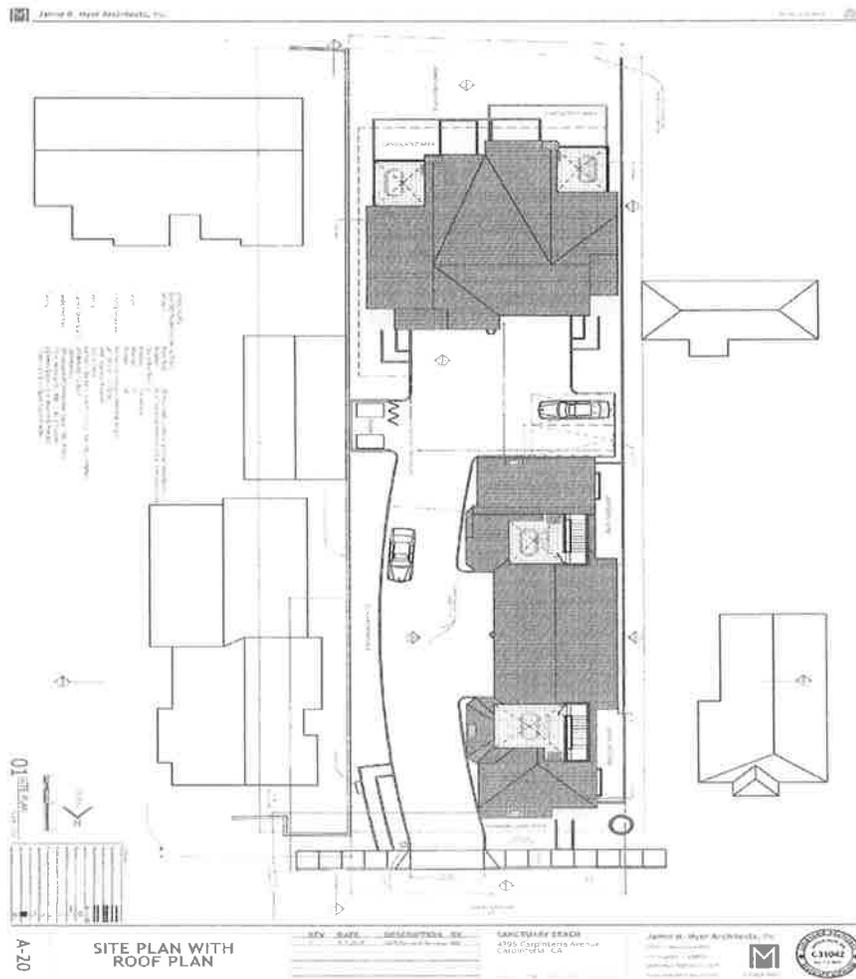
Site Plan for 4295 Carpinteria Ave with tree site shown in red circle

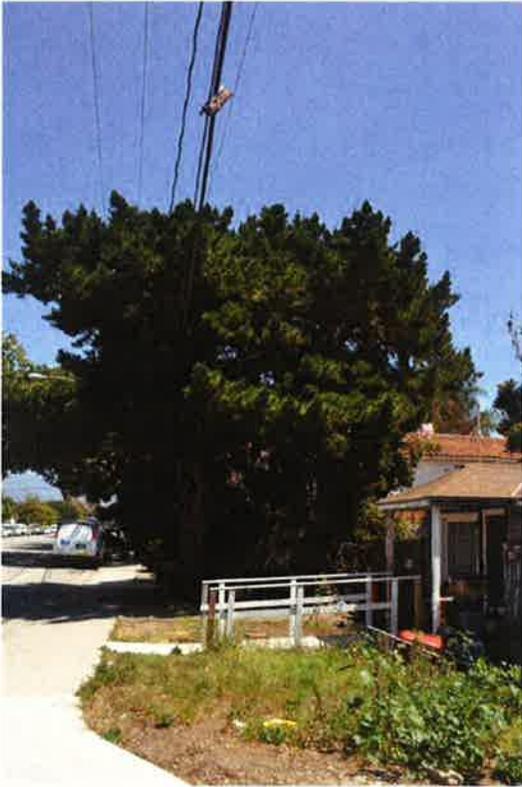
Looking East

4. Crown impacts - Mature Monterey Pines like this one are normally about 40' tall. This tree is under power lines thus it has been topped to about 32' tall. Topping is a destructive practice to trees that weakens their structure and increases the potential for disease to occur. Regular topping of the tree by utility crews will continue into the future.

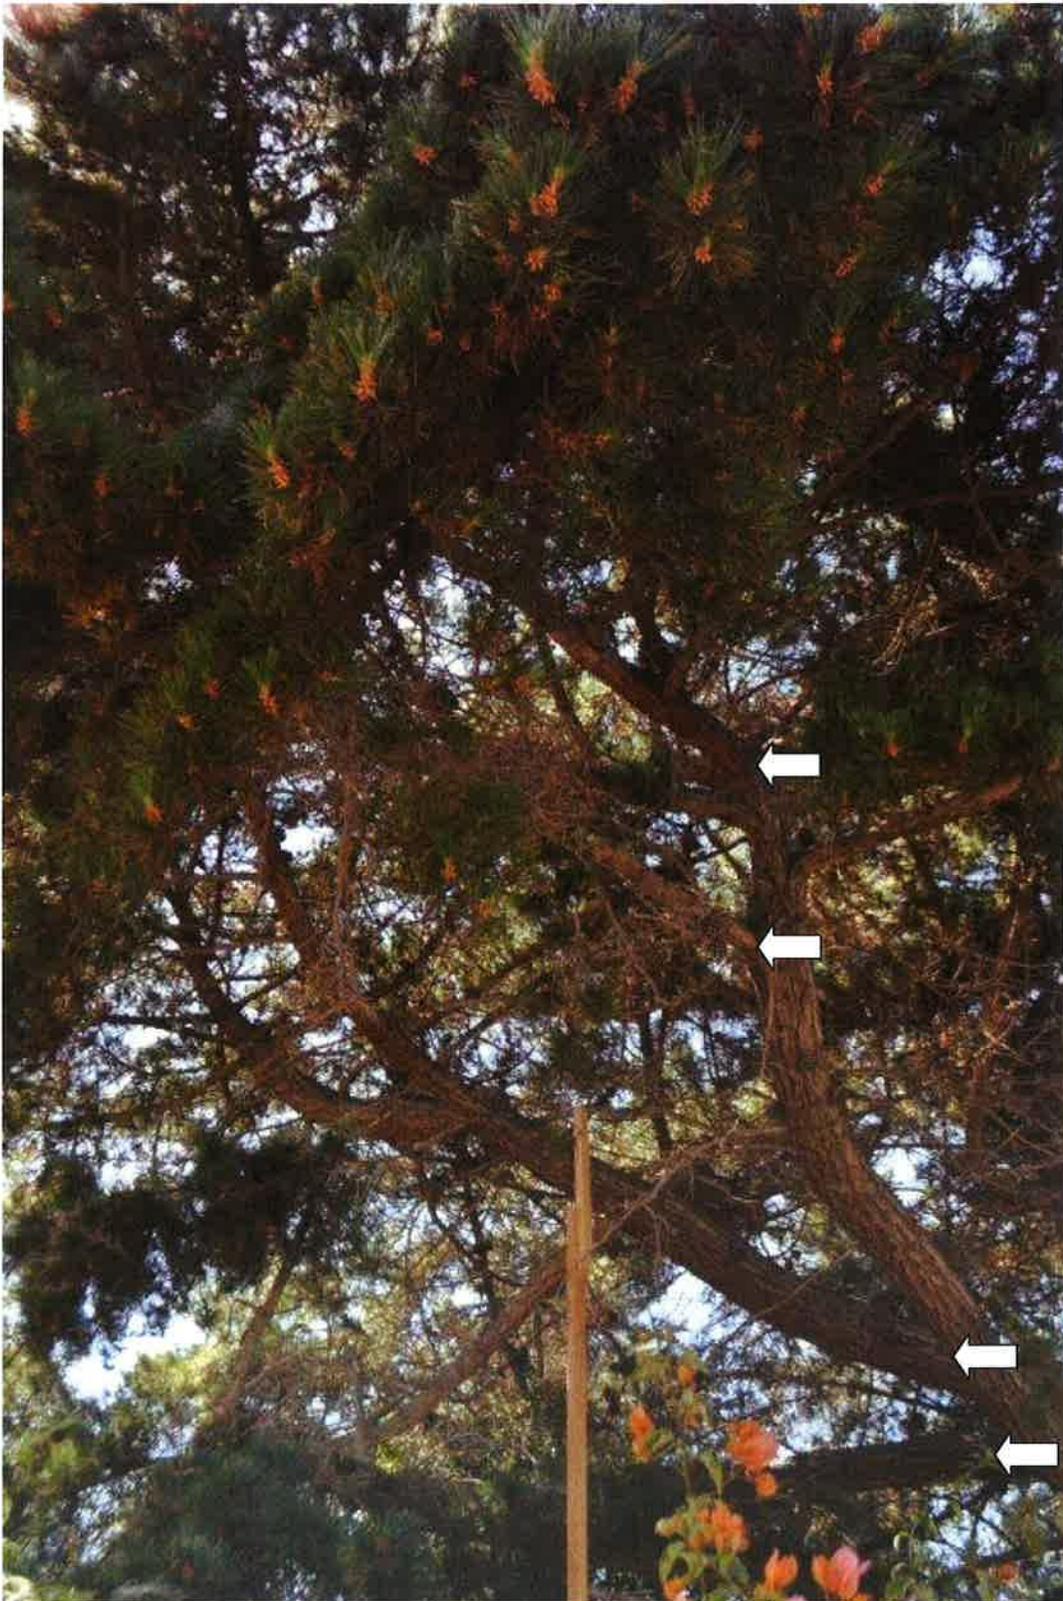
One of the height poles was broken during my visit, but based on the other height poles and design plans, several major scaffold limbs would have to be removed resulting the loss of between 25% to 40% of the canopy for this tree. In addition to being an additional stress to the tree, the foliage on the lower portion of the tree will have not fully regenerate due to the age of the tree and the shade from the new building.

Looking west detail-arrows showing potential pruning cuts

4. **CLEARANCE PRUNING** – Tree pruning during construction must be performed under the supervision of a Certified Arborist and not by construction personnel.

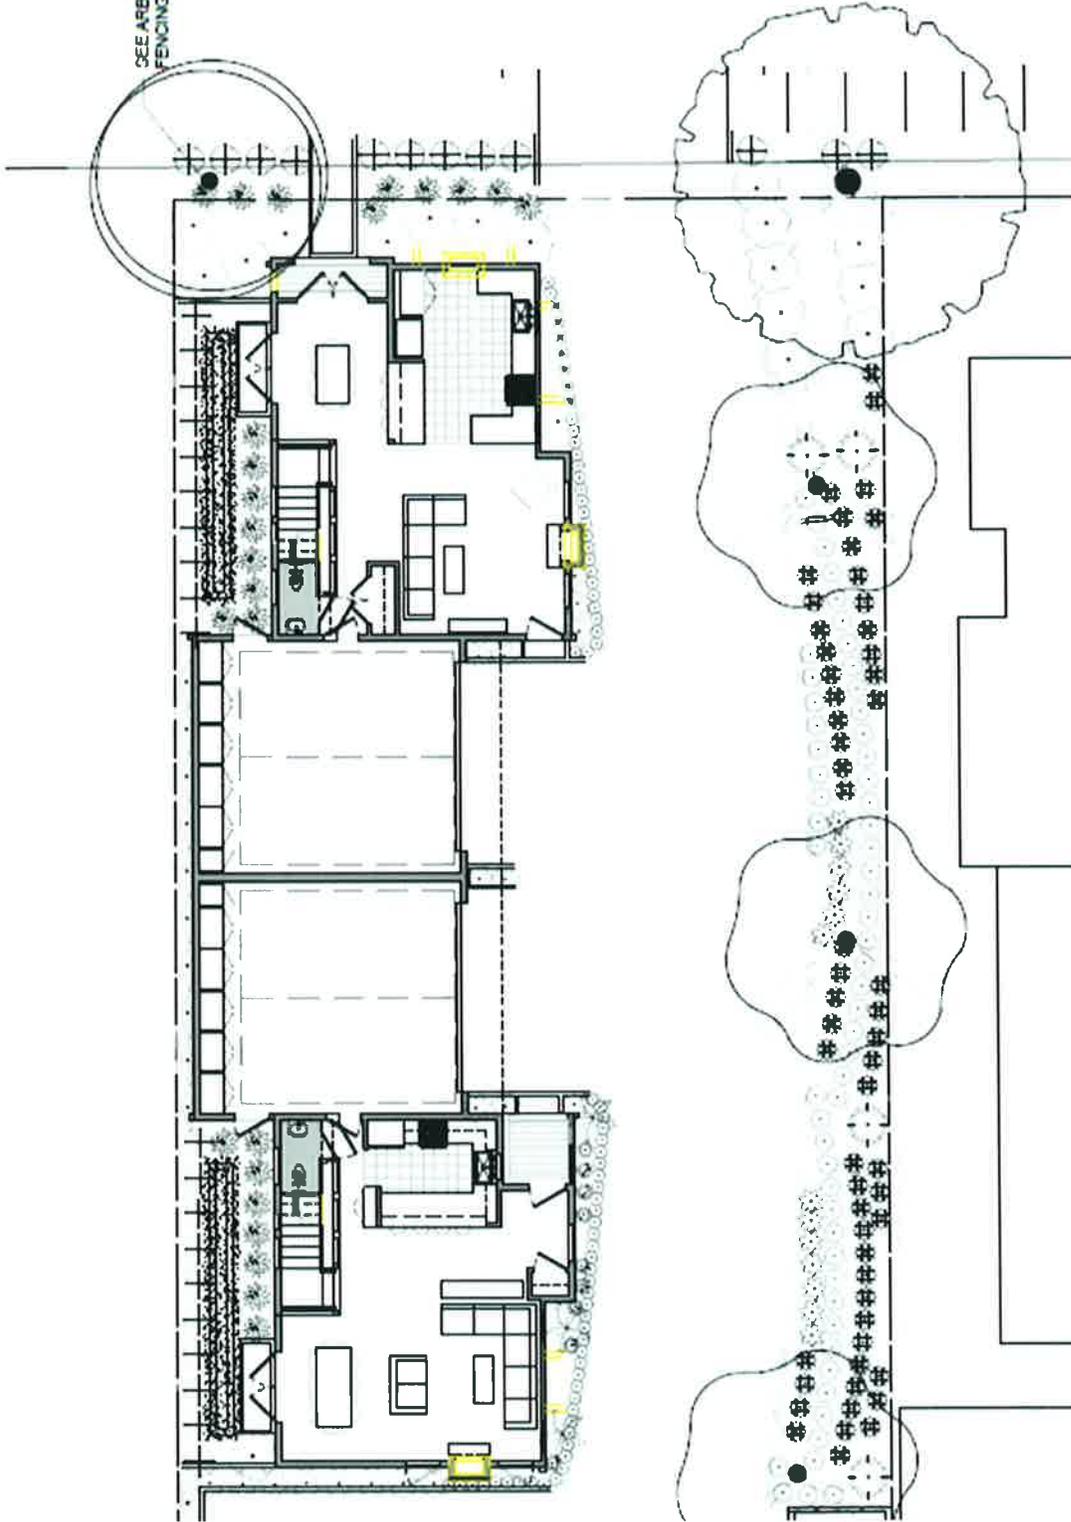
SEE ARBORIST
FENCING NOTE BELOW

- PINUS RADIATA, MONTEREY PINE**
- EXISTING ~~Cupressus macrocarpa / Monterey Cypress~~
- If tree dies during or after construction, replace with Pinus plera
- Laurus nobilis / Sweet Bay
- Metrosideros excelsus / New Zealand Christmas Tree

1. FENCING-In order to avoid compaction of soil, the area under the dripline of the tree should be fenced, with the exceptions as noted below. Fencing can be of high visibility plastic mesh or chain link a minimum height of 5 feet, mounted on steel posts driven 18" into the ground. Fencing must be in place prior to the arrival of any other materials or equipment and must remain in place until all construction is completed and final approval is given. Fencing must not be temporarily moved during construction. Fencing should have signage in English and Spanish 'Tree Protection Zone-No entry". This requirement does not apply to any surface currently covered with concrete.
