**CITY OF CARPINTERIA  
TREE ADVISORY BOARD**

#### Heath Ranch Park Tree Matters

**Kenneth A. Knight Consulting LLC**

Conduct a Level 2 risk assessment of five heritage Blue Gum Eucalyptus (*Eucalyptus globulus*) trees in Heath Ranch Park. A Level 2 assessment as defined by the American National Standard Institute (ANSI) A300 (part 9) Tree Risk Assessment standard is a detailed ground based 360 degree walk by each tree and visual inspection of a tree and its surrounding site using binoculars, mallet, probe, magnifying glass, diameter tape and trowel. A Level 2 assessment provides analysis of data, evaluation of risk and mitigation options.

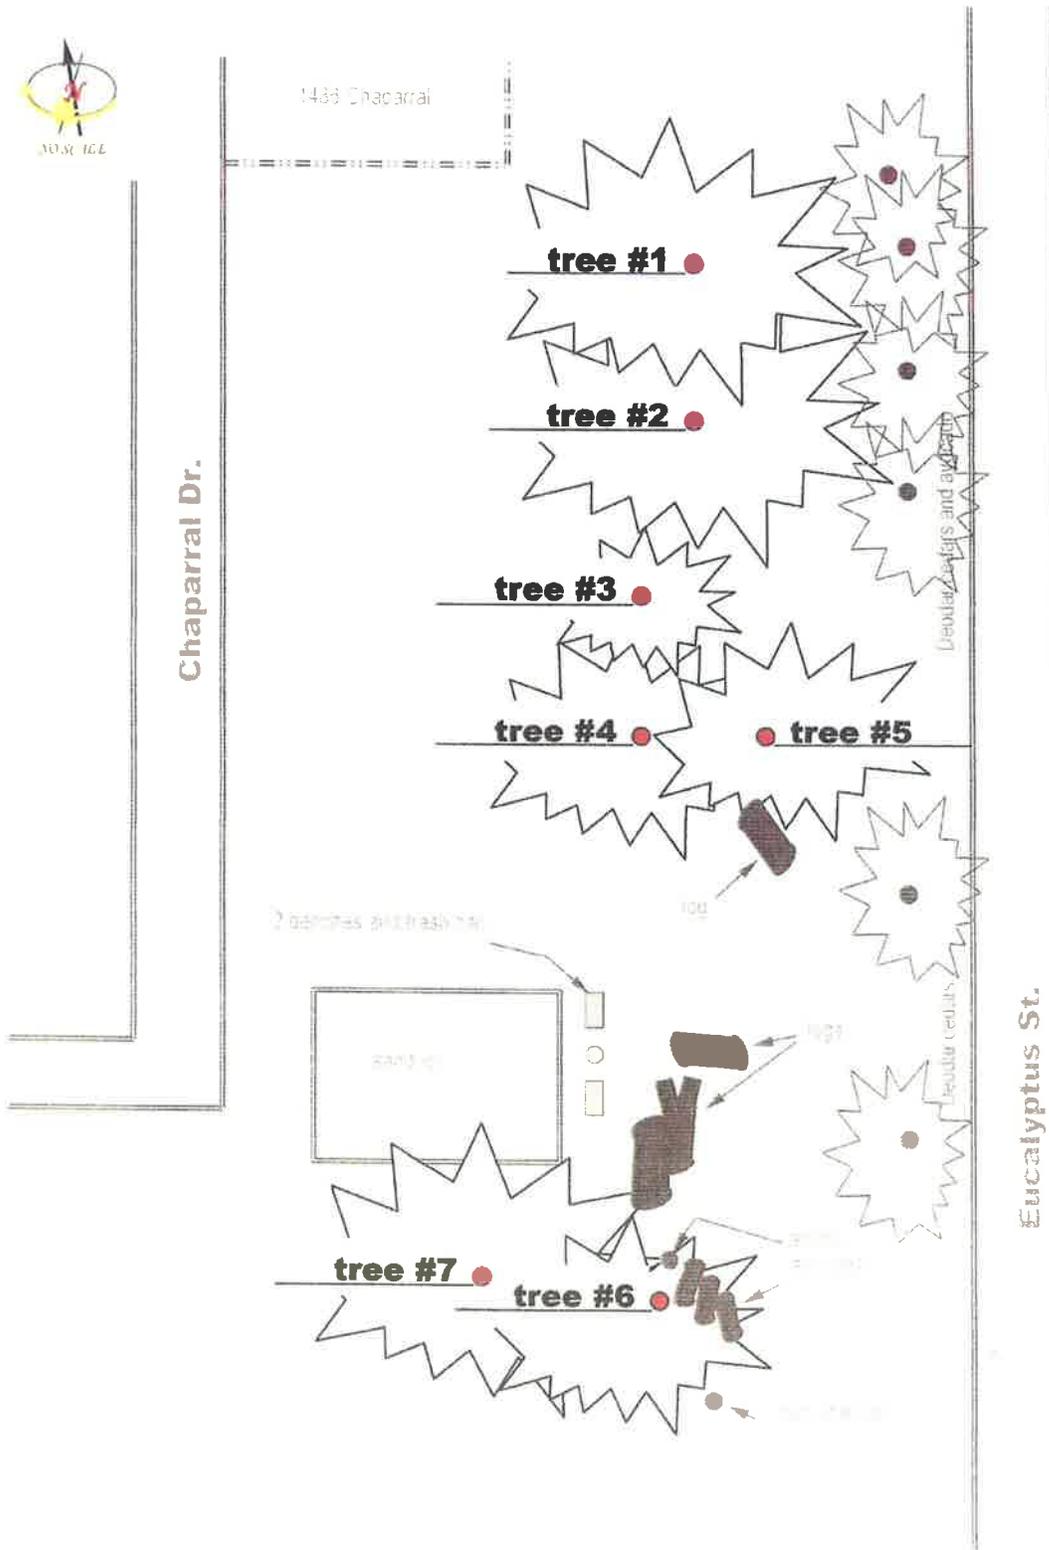
**Tree 2**  
**Species:** Tasmanian Blue Gum (*Eucalyptus globulus*)  
**DSH:** 69" Diameter at Standard Height  
**Height:** 110 feet  
**Canopy:** 95" (53' x 95')

**Observations:** Tree 2 appears to be in good condition. The burl on the bottom of the tree is primarily hollow and does exhibit evidence of sap ooze. This appears to be slime ooze, a harmless bacteria infection and not symptoms of damage from eucalyptus long horned beetle insect activity.

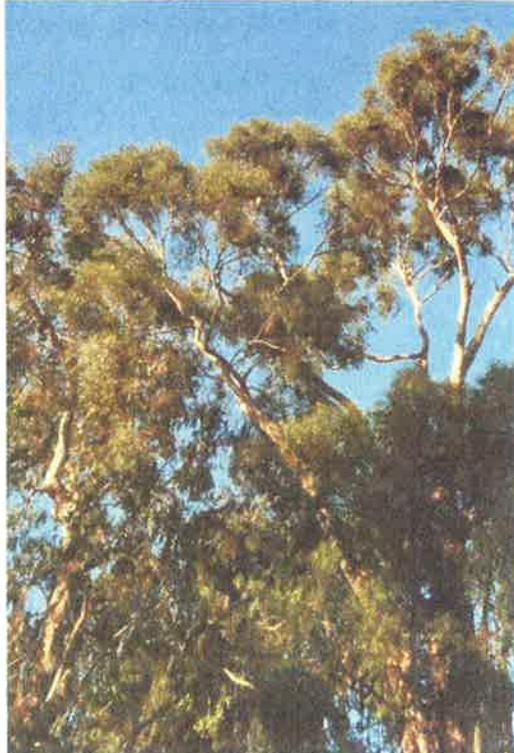
Potential scaffold reduction

Tree 6  
 Species: Tasmanian Blue Gum (Eucalyptus globulus)  
 DSH: 93" Diameter at Standard Height  
 Height: 95 feet  
 Canopy: 75"  
 Observations: Tree 6 appears to be in fair condition. The bottom of the tree is partially hollow, with a flat edge on the southeast side indicating root issues, and sap ooze. The sap appears to be slime ooze, a harmless bacteria infection and not symptoms of damage from eucalyptus long horned beetle insect activity.

Tree Defects: The parts of the tree most at risk of failure are 1) the overextended branches on the north side of tree, 2) the three scaffolds next to each other about one quarter up the tree on the west side. 3) The scaffold on the southeast side. 4) The base of the tree and possible insect/root issues

3. Crown reduction is one method of reducing risk by reduce the weight of long, usually horizontal scaffold extensions with little taper and most of its foliage at the end. Crown reduction can reduce the likelihood but not guarantee the avoidance of limb drop. Crown reduction does increase the likelihood of infection and disease entering cut areas of older trees, permanently disrupts their character, increases their long term maintenance needs, and could cause the tree to enter into a death spiral. General crown reduction to reduce risk liability is not recommended in this report, although specific scaffold and branch reductions are recommended for consideration
